# Geomorphic response to catastrophic flooding in north-central Pennsylvania from Tropical Storm Lee (September 2011): Intersection of fluvial disequilibrium and the legacy of logging

## ABSTRACT

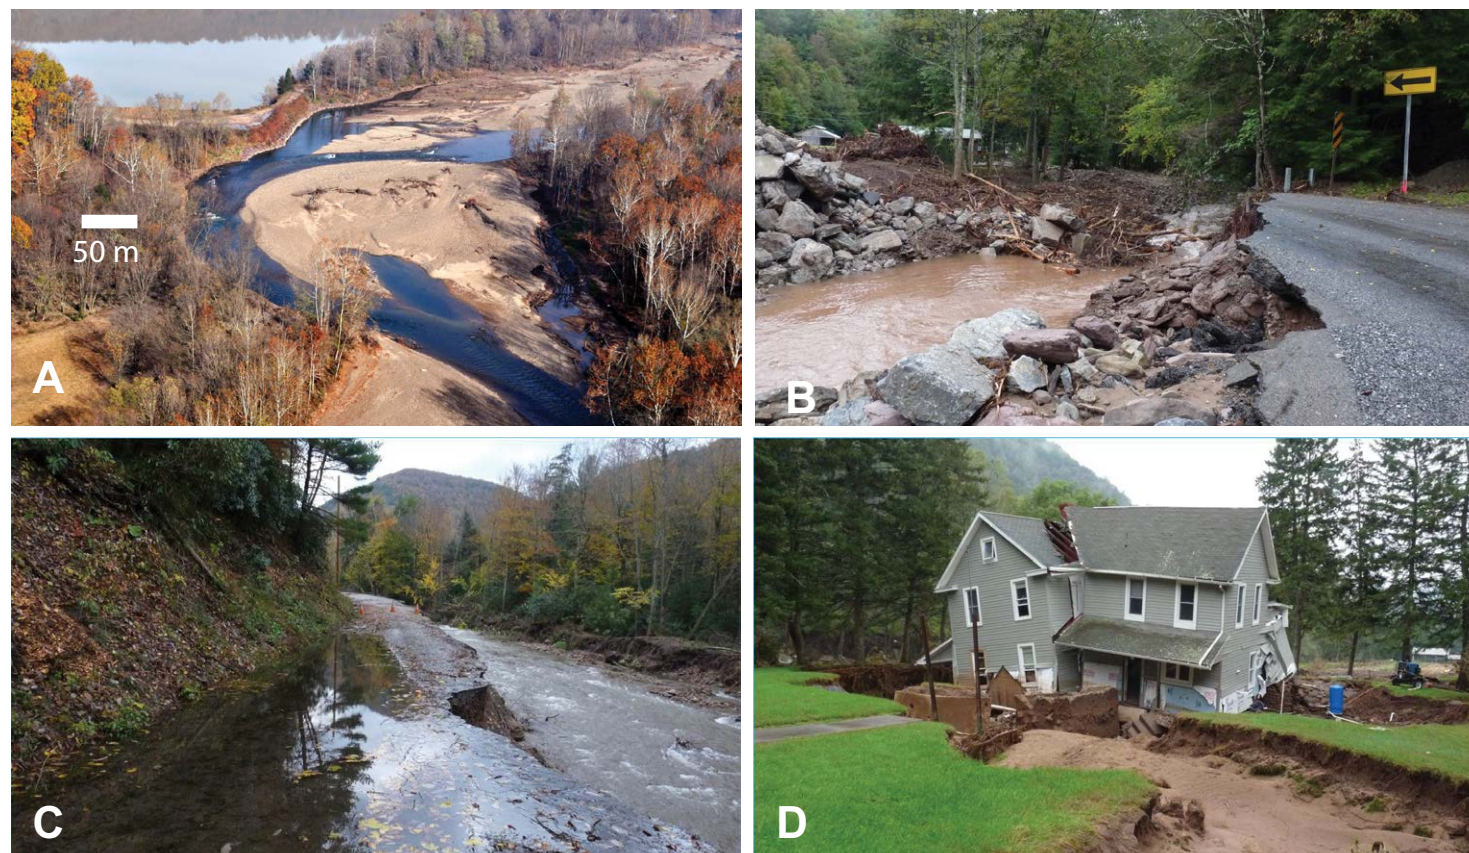
**Figure 1.** Examples of erosion and deposition in north-central Pennsylvania from Tropical Storm Lee. (A) Extensive gravel bars formed in a disequilibrium zone on lower Fishing Creek. (B) Washed out bridge in upper Muncy Creek. (C) Eroded road along Big Bear Creek, upper Loyalsock Creek watershed. (D) House eroded on a Pleistocene terrace, Loyalsock Creek.

Detailed ground and geographic information system (GIS) based mapping using preflood air photos taken in June 2011 and postflood low-altitude photography from a helicopter survey (3 November 2011) were used to map geomorphic changes along ~250 km of 4 major tributaries to the West and North Branches of the Susquehanna River, Lycoming Creek, Loyalsock Creek, Muncy Creek, and Fishing Creek (Fig. 2A). Chutes were scoured across floodplains and terraces along the insides of many meander bends, bed and bank erosion was widespread, and many stream reaches underwent adjustments in channel pattern from single to multithread channel systems. Perhaps most remarkable was the volume of coarse gravel transported by the flood (Fig. 1A).

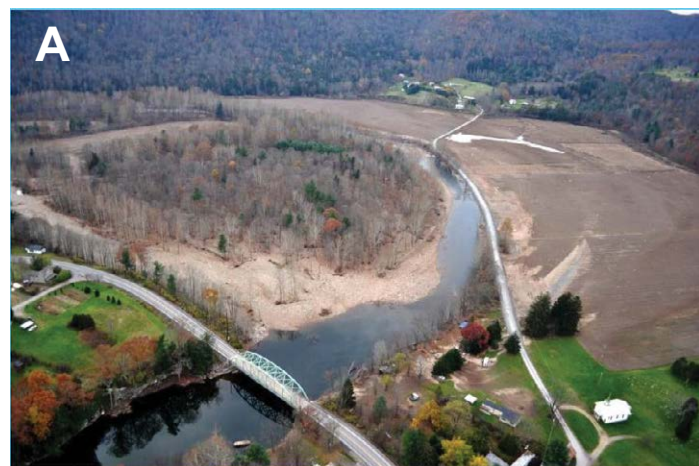
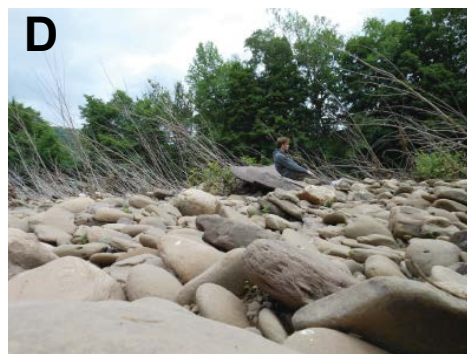
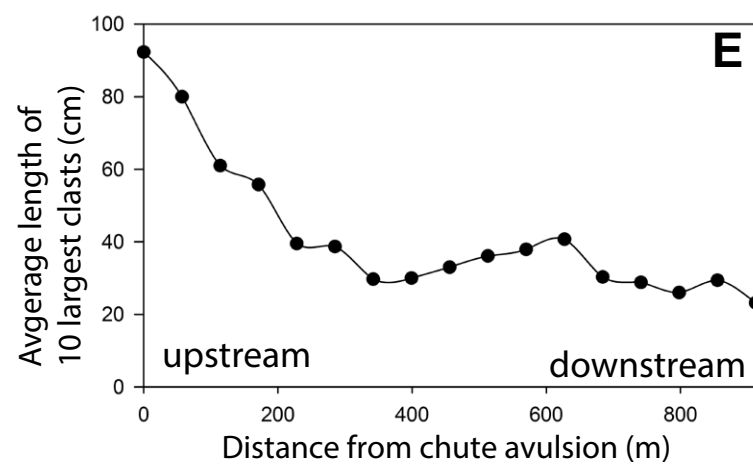
Figure 9. Hillsgrove chute complex on central Loyalsock Creek. (A) Oblique aerial view of the chute. (B) Geomorphic map. (C) Preflood lidar (light detection and ranging) image showing berm and paleochute. (D) Ground view of imbricated gravel in the upstream portion of the chute (flow from right to left). (E) Surface grain-size variation along chute axis.

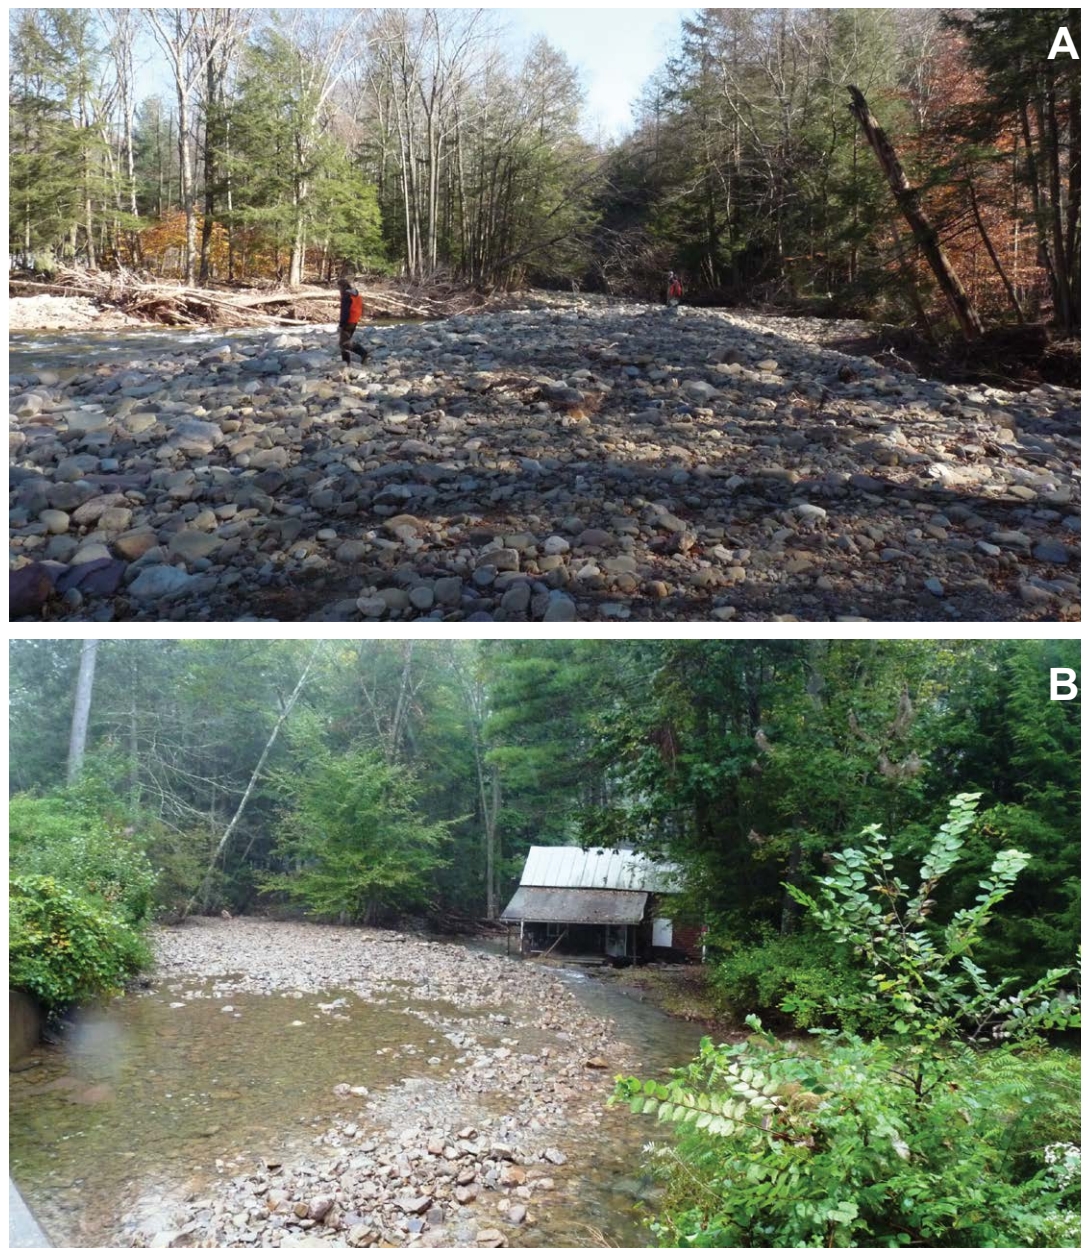
**Figure 12.** Examples of bar aggradation filling channels above floodplain surface. (A) Bar in upper Fishing Creek near Elk Grove. (B) Fill and channel avulsion onto floodplain in Little Bear Creek, tributary to Loyalsock Creek, near Barbours.

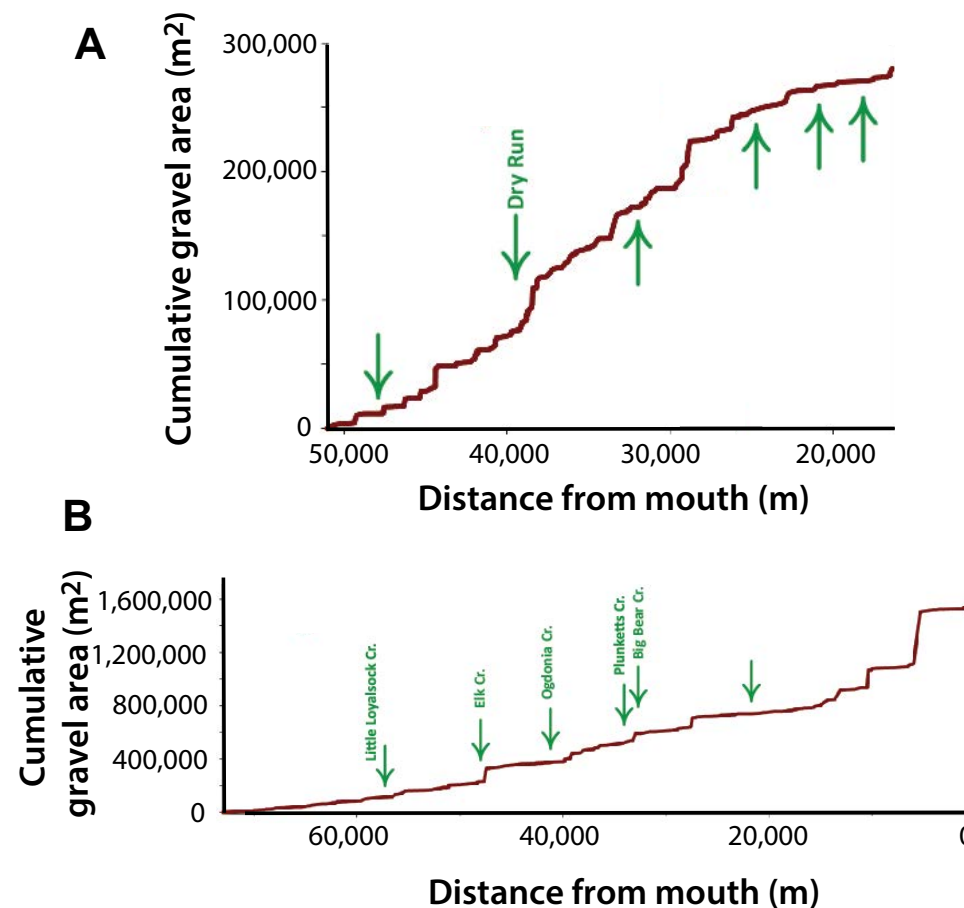
Figure 15. Gravel sources and tributary junctions. (A) Cumulative gravel area versus distance from the mouth of Muncy Creek. Green arrows show junctions of major tributaries, most of which are unnamed. (B) Cumulative gravel area versus distance from the mouth of Loyalsock Creek.

Cumulative gravel bar area was plotted along the mainstream channels in an effort to determine whether flood gravels were sourced from channel and bank erosion or from headwater sources through tributaries (Fig. 15). In several locations there are distinctive increases in cumulative gravel (Fig. 15; steps in the red line) that coincide with tributary junctions (green arrows in Fig. 15).

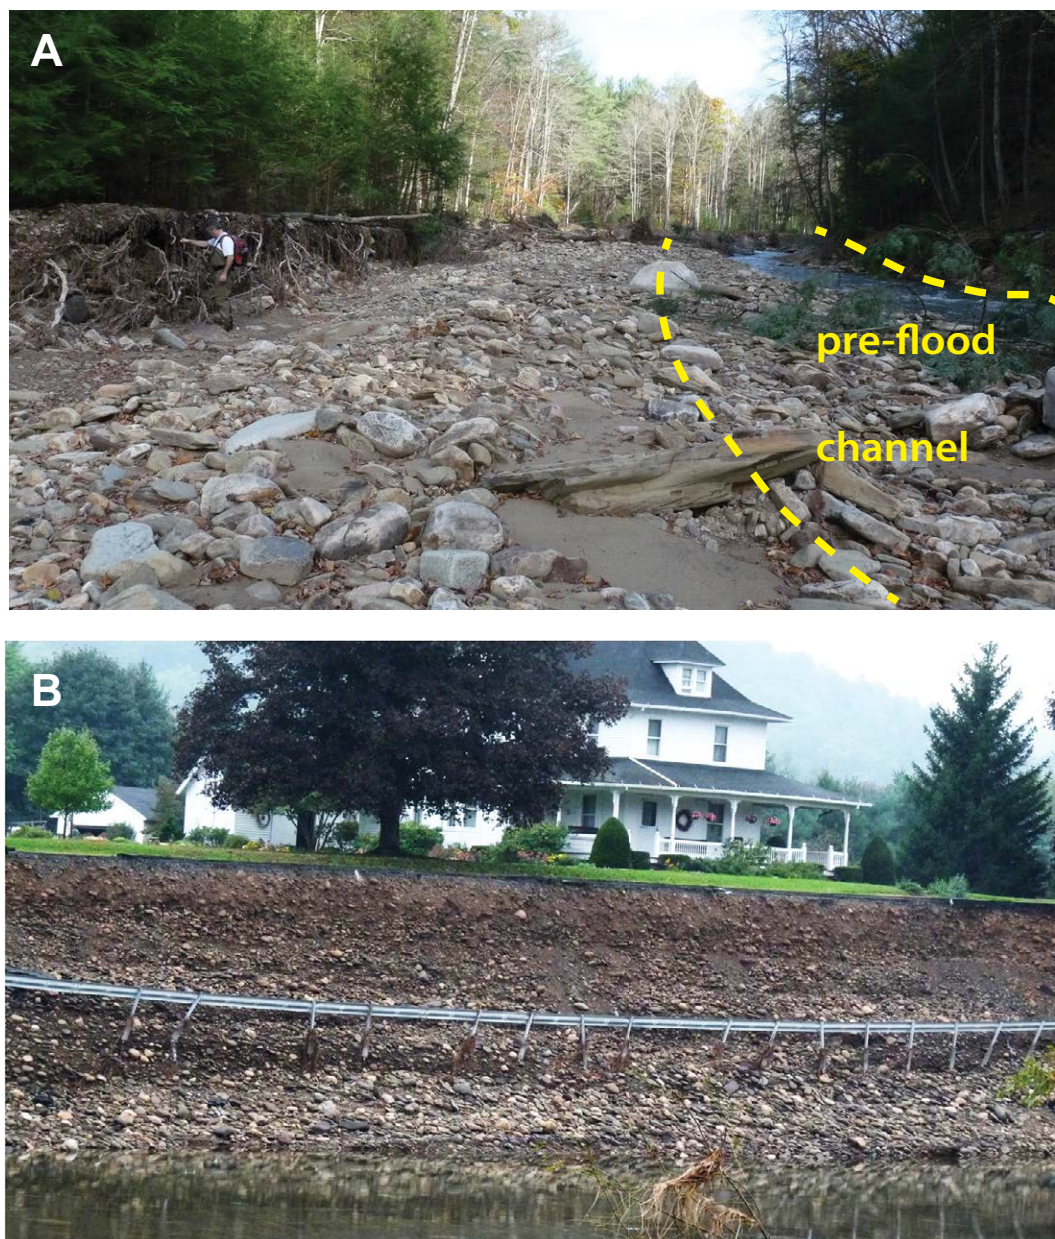
**Figure 16.** Examples of bank erosion and channel widening. (A) More than 100% widening along Big Bear Creek, tributary to Loyalsock Creek. Note the lack of soil on the eroded channel bank and the abundant newly exposed tree roots. (B) Collapsed guardrail and eroded highway along lower Loyalsock Creek. Note the extensive reddish soil on the eroded bank of this Pleistocene terrace.

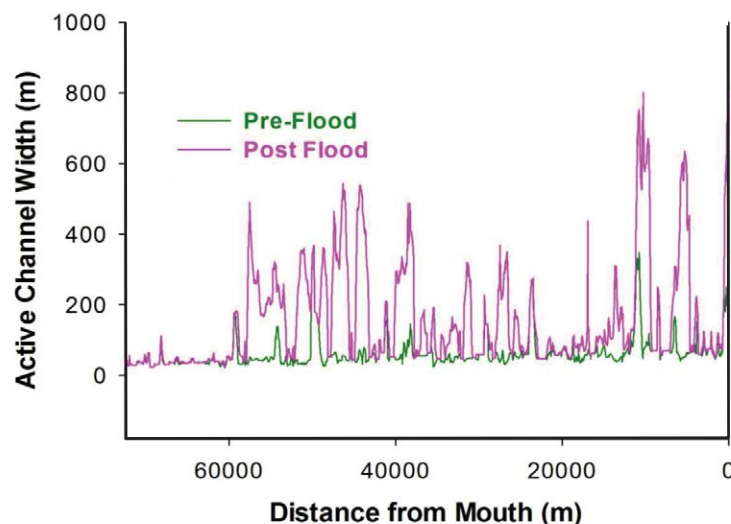
Figure 17. Example of large increases in active channel width along Loyalsock Creek. Changes were measured from comparing preflood and postflood aerial photography using geographic information system.

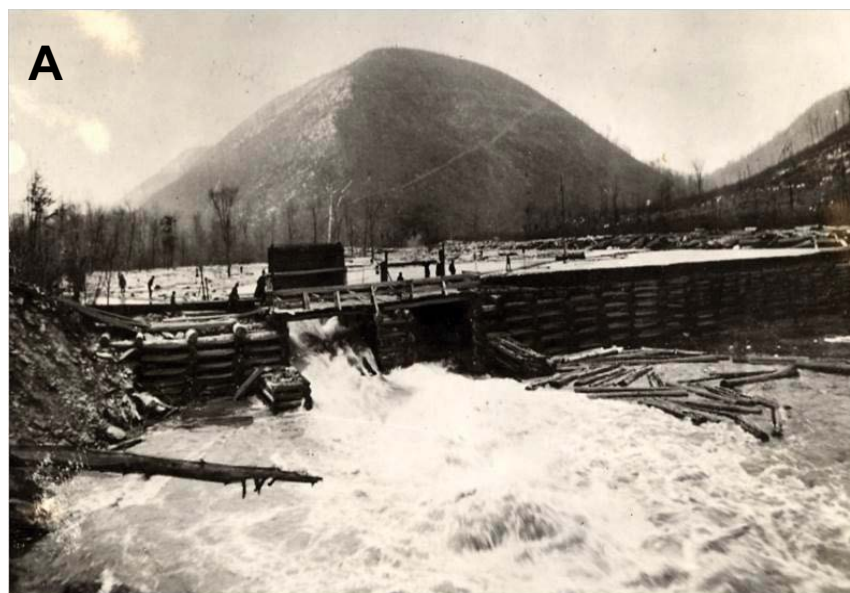
Figure 24. Impact of widespread clearcutting on north-central Pennsylvania watersheds. (A) Photo in Pine Creek watershed in 1908. Note the bare hillslopes and logs moving through the splashdam in the foreground. (B) History of timber harvest on the West Branch Susquehanna River (red line). Blue bars show large floods on the river.

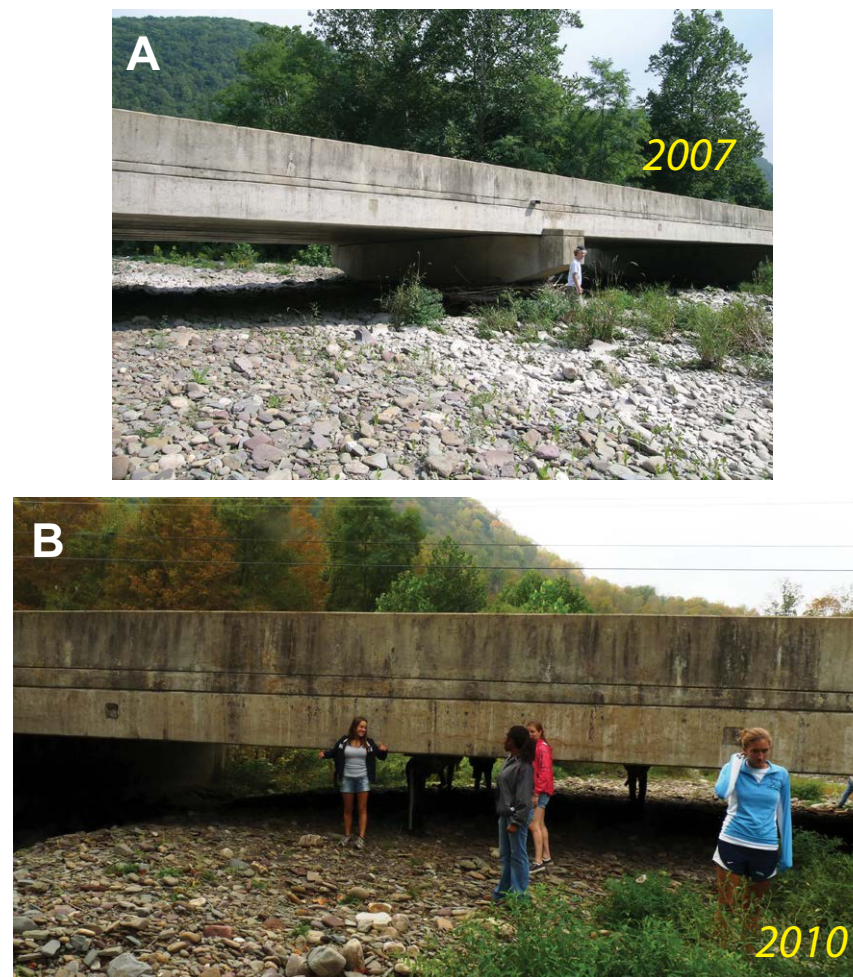
Figure 31. Ground view of aggradation at Highway 14 bridge at Roaring Branch. Several meters of remobilized logging legacy gravel had to be removed from under the bridge several times in the past 20 yr. (A) View in July 2007. (B) View in October 2010, showing ~1 m of aggradation in 4 yr.
