# Key Principles to Consider When Discussing Flood Mitigation and Management Alternatives For Streams in North-Central Pennsylvania

Benjamin R. Hayes, Ph.D., Watershed Sciences and Engineering Program, Bucknell University

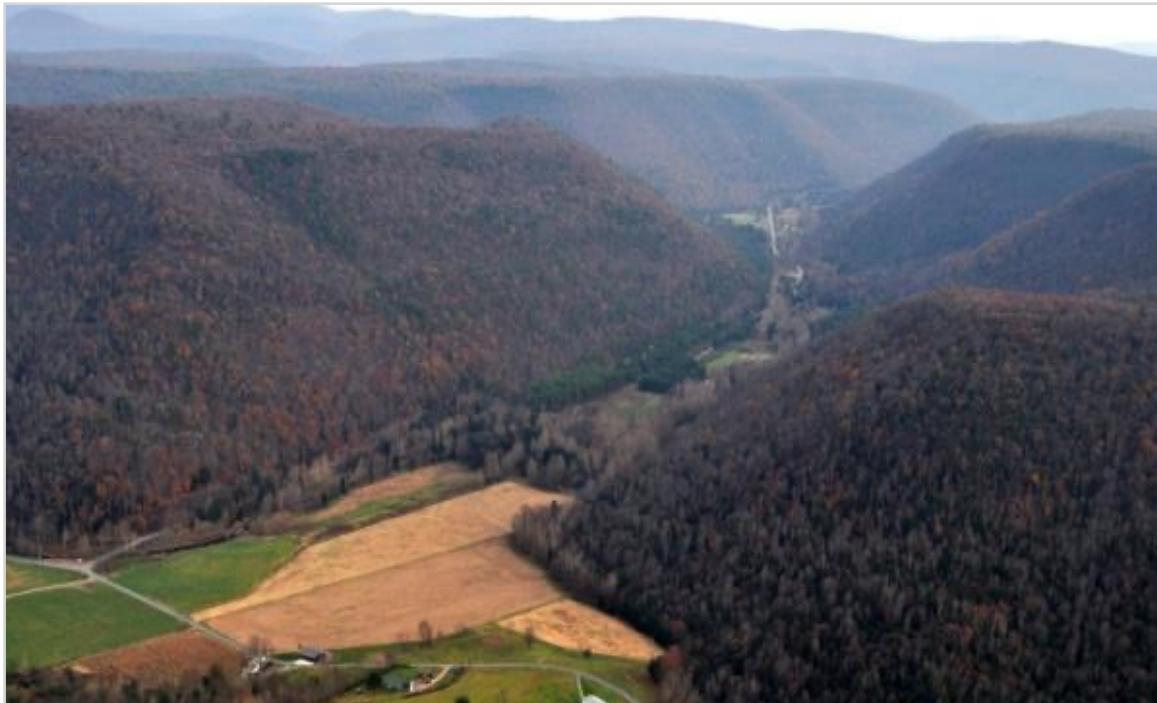
**Figure 1.** Lycoming Creek, an example of watershed in the Deeply-incised Valley Section of the Appalachian Plateau Province in north-central Pennsylvania. The high relief, steep hill slopes, and complex alluvial architecture in the valley bottom makes streams in this region especially vulnerable to catastrophic flooding, stream instability, and channel change during intense and prolonged storms.

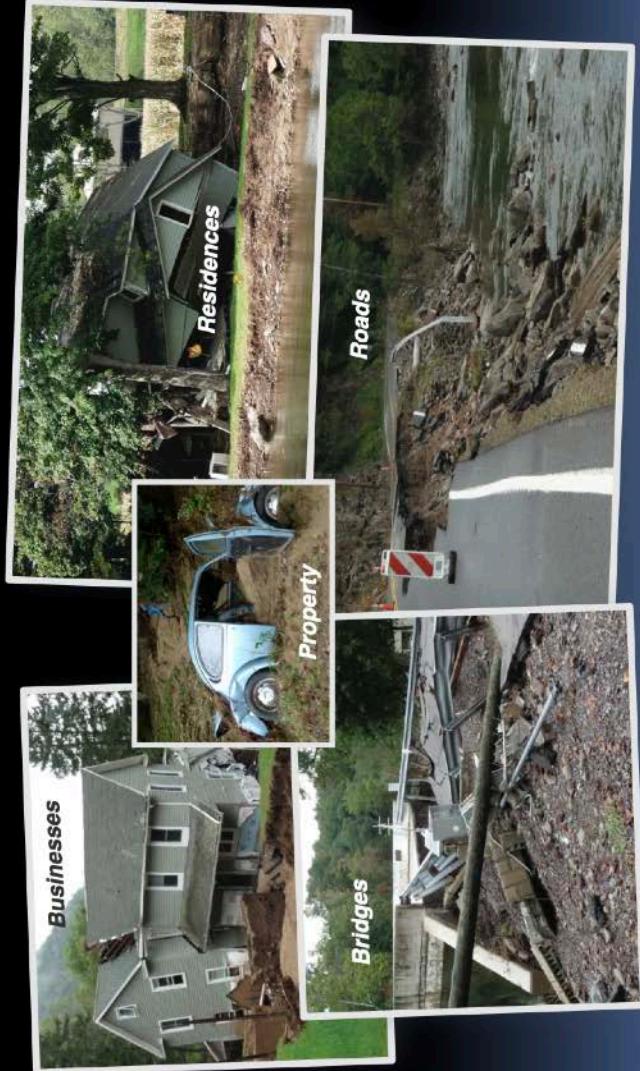
**Figure 17.** Developing flood mitigation and stream maintenance programs that incorporate these understandings is critical to reducing the costs of floods in Pennsylvania. PennDOT and insurance companies report that fluvial erosion and deposition are the number one cause of property damage. A more nuanced understanding of how gravel bed streams in the northern tier behave during floods can help planners, engineers, and first responders anticipate sections of the streams that need protection and other sections of the stream that need space to adjust during floods.

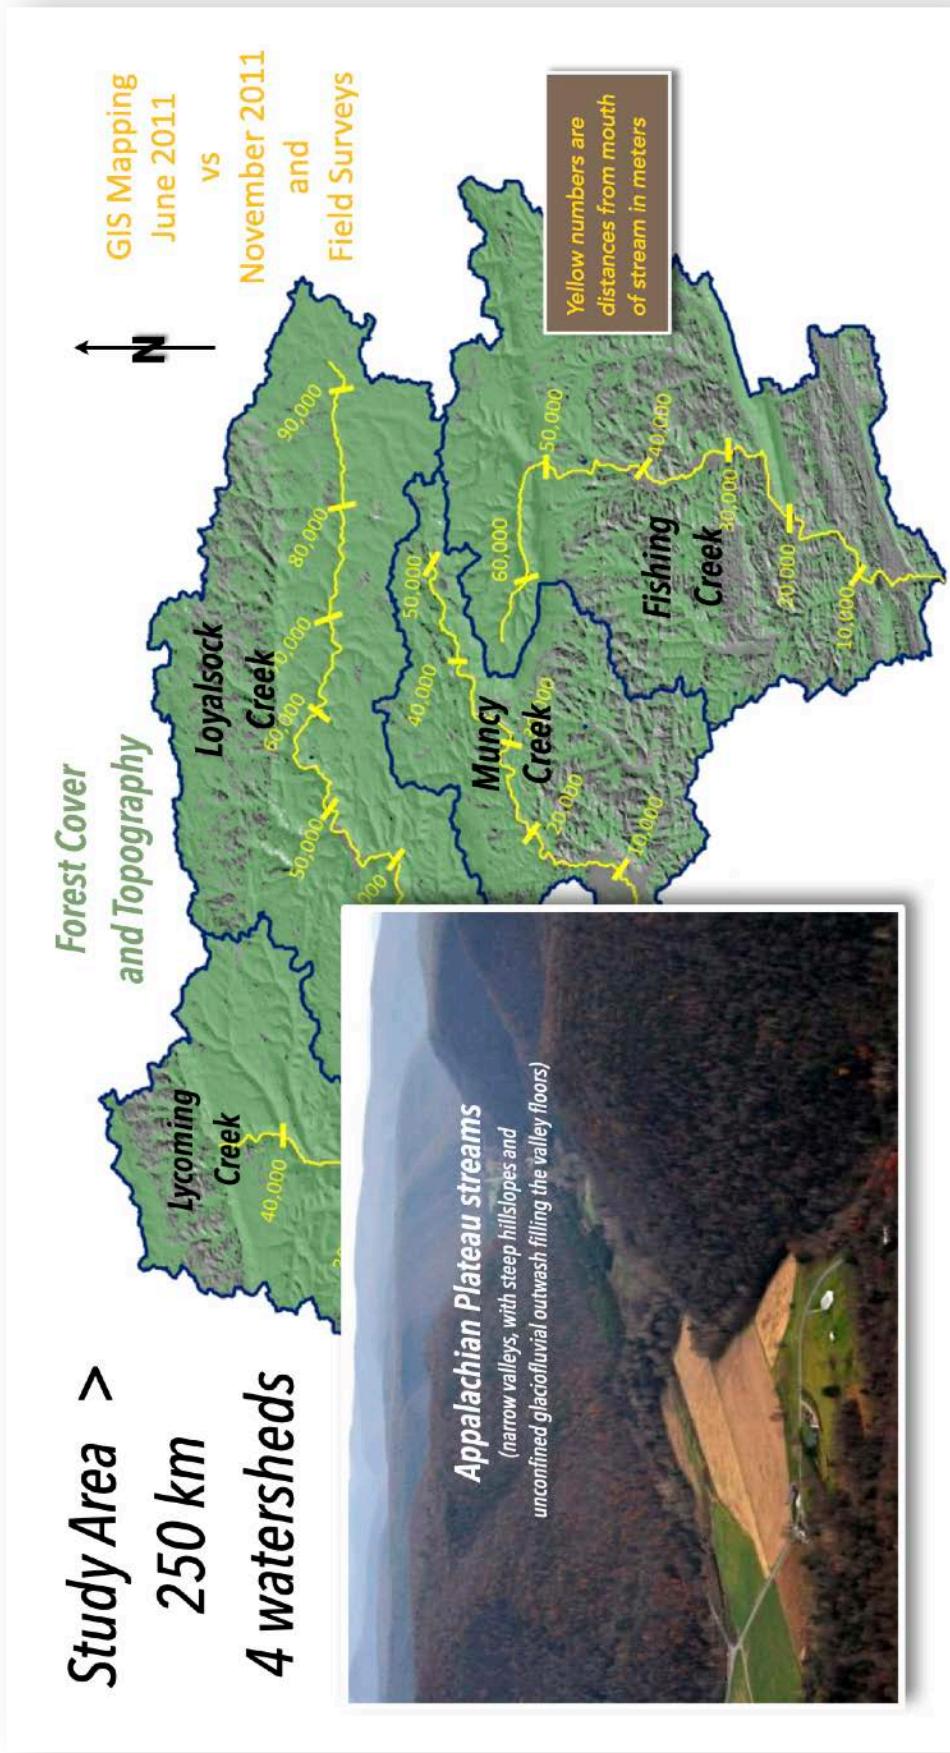
**Figure 19.** Following Tropical Storm Lee, geomorphology professors from Bucknell University (R. Craig Kochel and Benjamin Hayes) and their students conducted a detailed study of four watersheds impacted by flooding - Lycoming Creek, Loyalsock Creek, Muncy Creek, and Fishing Creek. Their study involved aerial flyovers by helicopter, ground surveys, and detailed mapping using geographic information systems (GIS) software. The data and findings were published in the journal Geosphere under open-access privileges, meaning it available for free to the public.

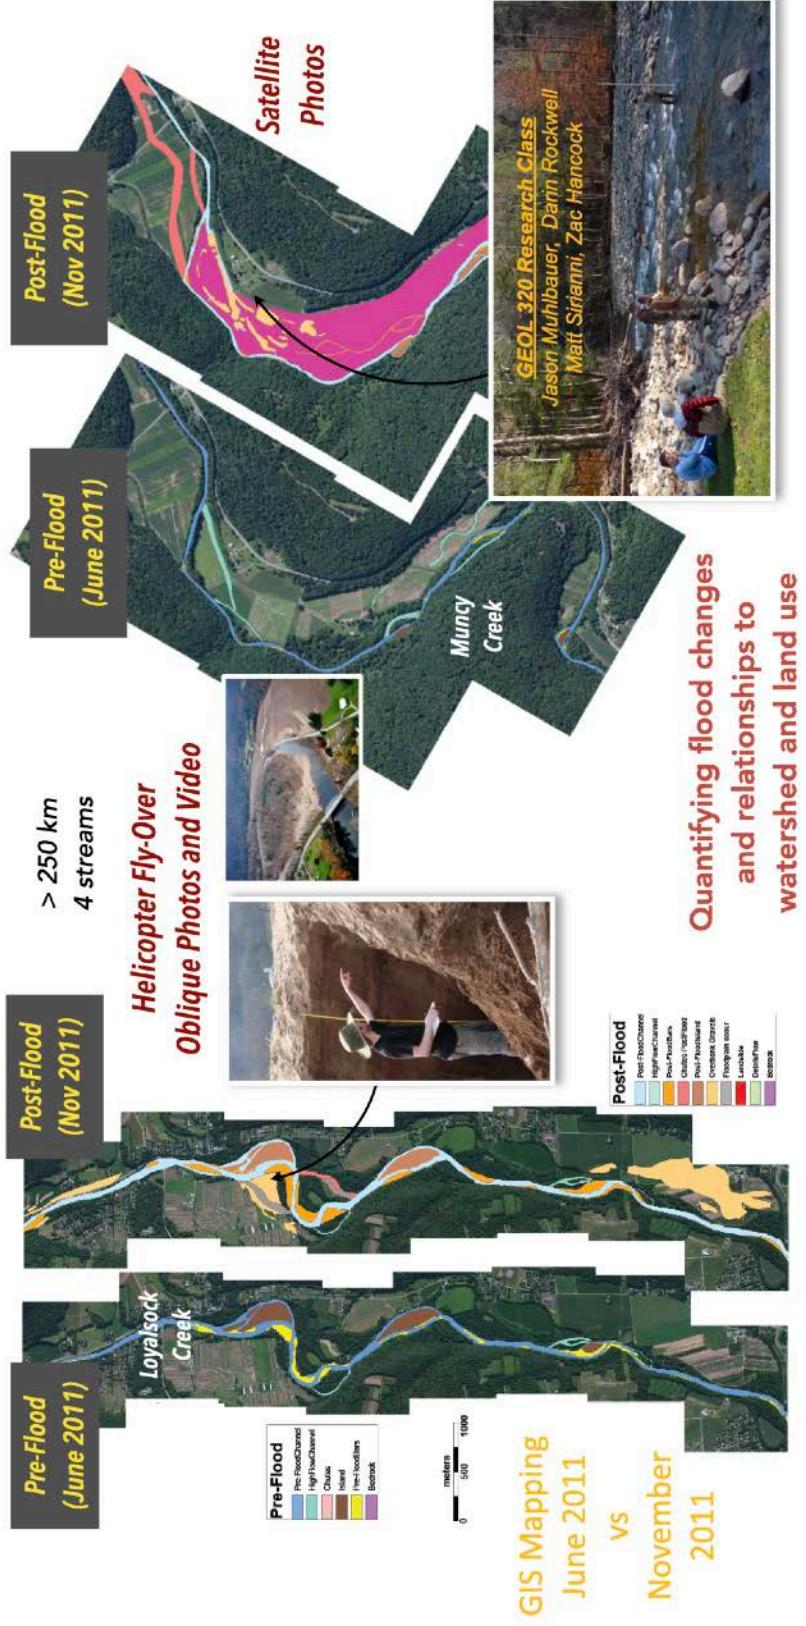
**Figure 20.** This slide provides an example of the data and maps produced in the study. The digital maps in the GIS software were combined with notes from the field surveys to quantitatively assess the amount of erosion and deposition that took place during and after the flood, as well as document how the network looked before and afterwards. Oblique photos and videos taken during the low-altitude helicopter floods were combined with aerial photographs (Google and Bing satellite images) as well as Lidar digital terrain data to determine change in three dimensions.

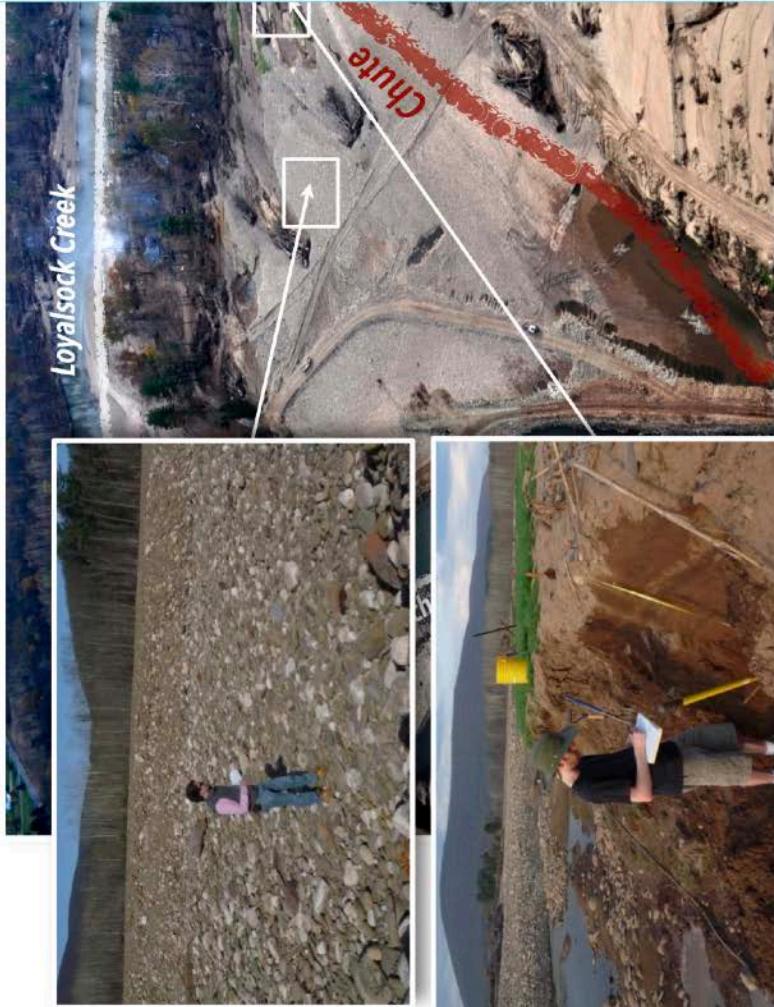
**Figure 21.** Photos and maps showing catastrophic change as massive amounts of sediment and water in Lycoming Creek worked its way past the area near the Game Commission Farm. As much as 4 feet of sand and gravel were deposited over tens of acres of cropland and the stream eroded “chutes” or side channels on the inside of meanders, cutting off the river and in other places fill the former channel and newly-carved chutes with bars and lag sediments deposited during the waning stages of the flood. The geomorphic map on the right shows the degree to which the channel reoccupied old side channels that it used to accommodate flood flows in the historic past, before the channel was straightened and bermed in the 1800s.

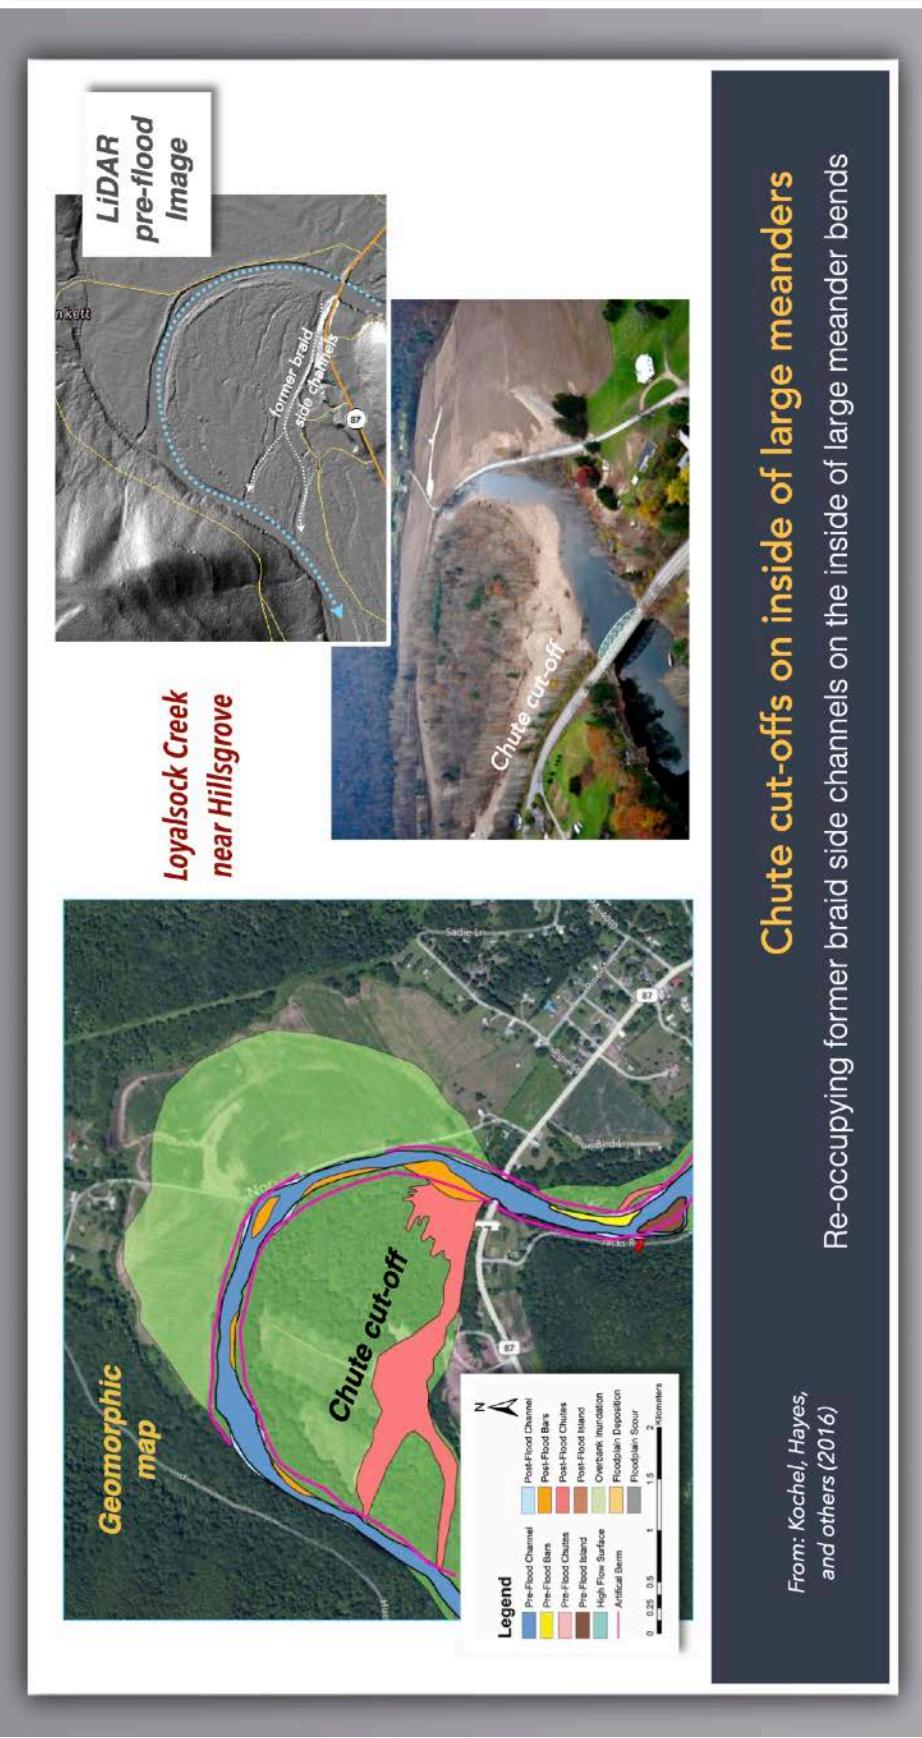
**Figure 22.** Another example of “chute cut-offs,” which was the dominant way flood waters in the main stem rivers (Loyalsock Creek near Hillsgrove in this example) caused property damage. With so much energy, the stream erodes a “chute” or channel in a former side channel on the inside of the meander (visible in the Lidar image in the upper right). This newer “chute” channel essentially cuts-off flow in the outside of the meander of the main channel, hence the term “chute cut-off.”

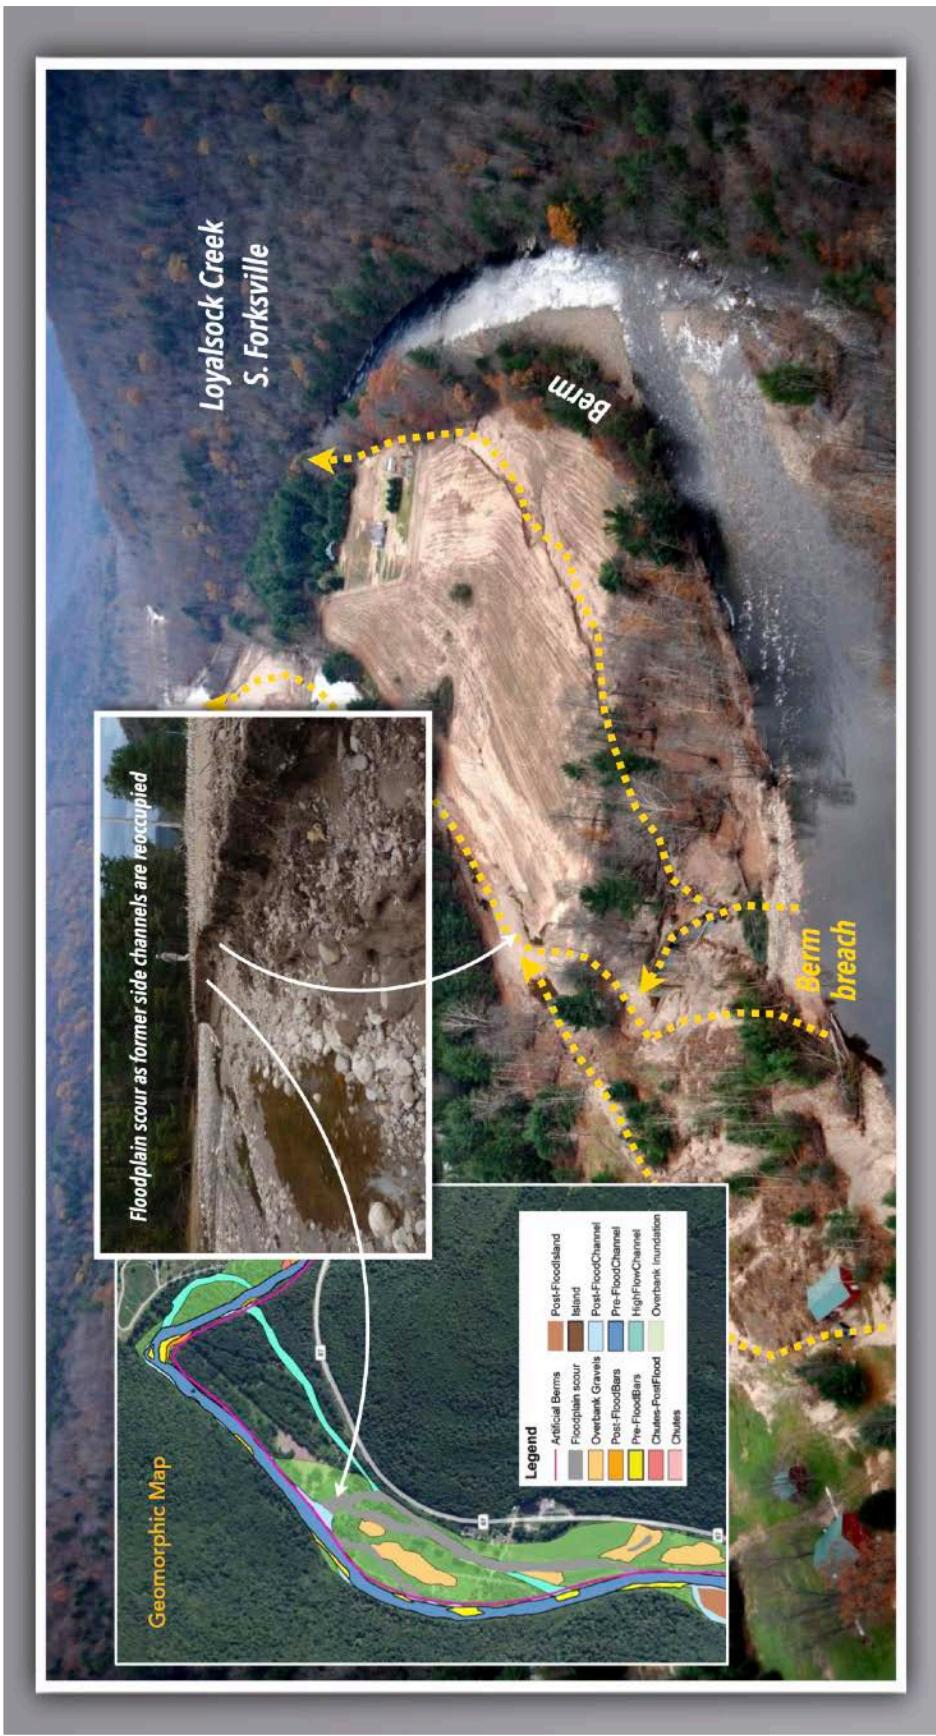
**Figure 23.** Another mode of failure during major floods is the breaching of relic logging berms, which allows flood waters to carve new channels across properties on the insides of the meanders, threatening homes and destroying farm fields in these locations. The Lidar images (lower left) reveal that prior to the construction of these berms, the river used to flow there.

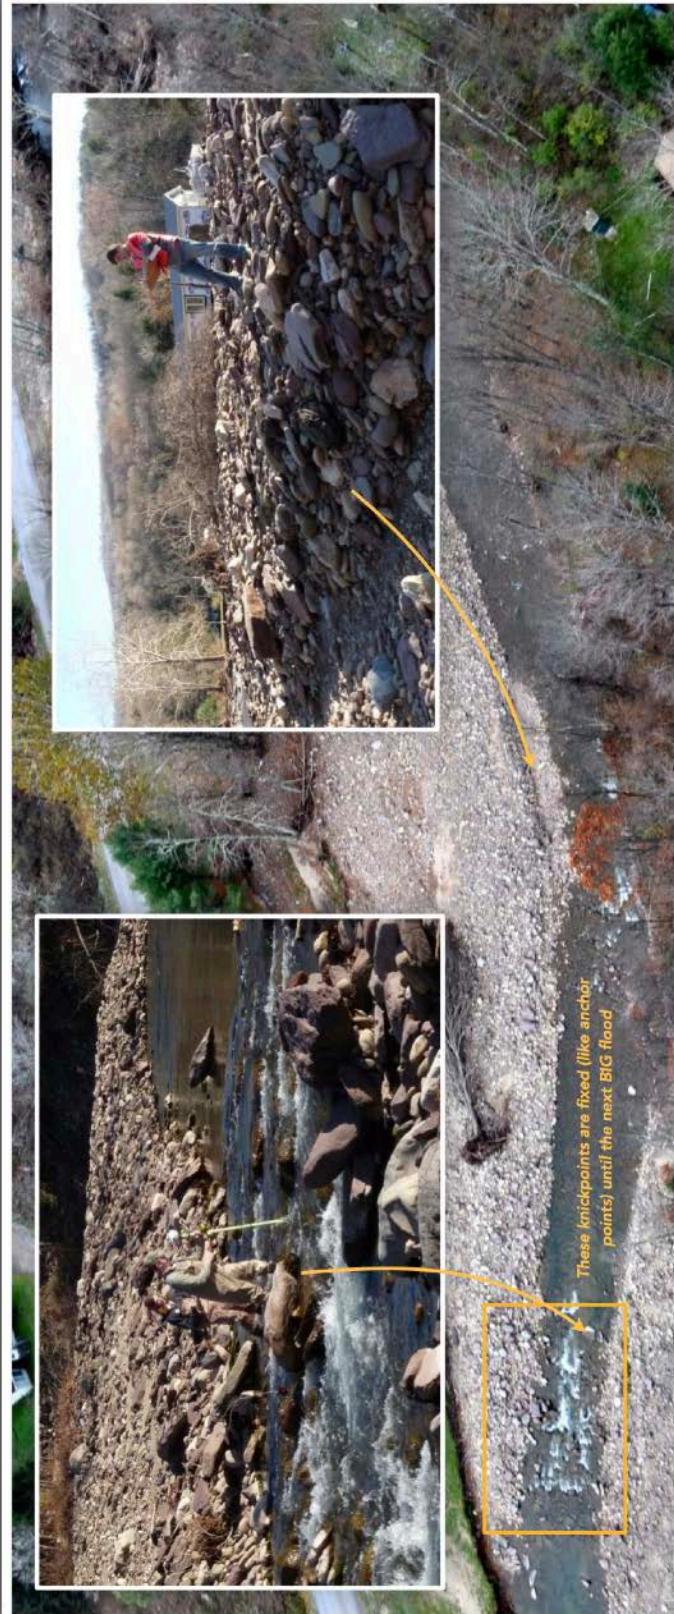
**Figure 25.** The steeper headwater tributaries are especially prone to sediment erosion and transport during major floods. This image shows the degree of floodplain stripping and subsequent new gravel bar deposition that can take place within one flood event. The size and amount of boulders moved during these floods is staggering. Many of the boulder clusters will remain in the channel to act as grade control structures until the next major flood. Adjustments in the gradient (slope) of the channel is one way braided gravel bed rivers rapidly respond to floods. The streams appear to be establishing a new equilibrium channel gradient, blasting away relic logging dams and structures that impeded this adjustment and seeking a new channel gradient and pattern that can accommodate modern flood magnitudes..

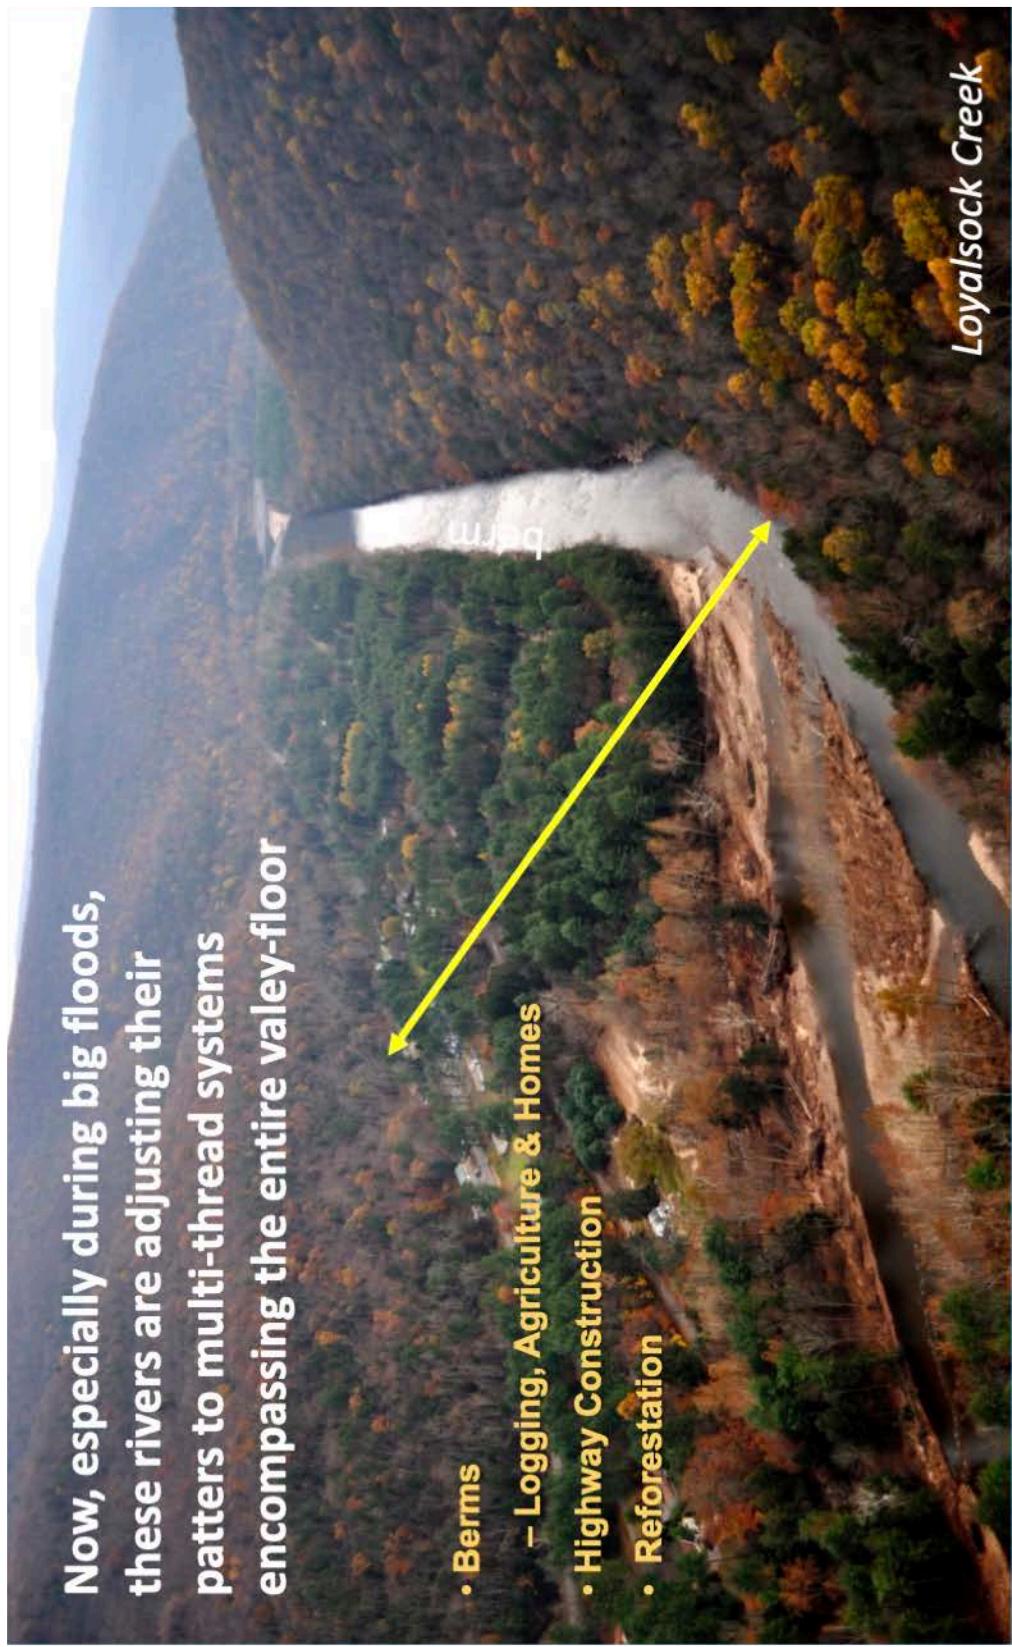
**Figure 29.** In the past we have altered the pattern of these streams, converting them from a naturally occurring multi-threaded state to an oversimplified single channel condition, primarily by dredging, straightening and berming them. Following threshold-crossing floods since Hurricane Agnes fluvial the fluvial system is out of equilibrium and can be expected to remain in an unstable, constantly shifting condition for decades to come.

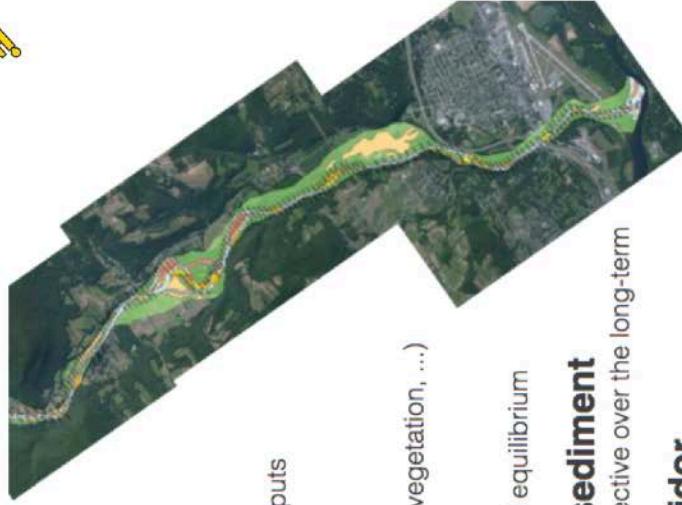
**Figure 31.** This slide summarizes several of the key concepts and findings presented earlier in the context of "river corridor" approaches to managing streams and rivers in the northern tier of Pennsylvania. This type of approach is adaptive and proving cost-effective, but not easy. It will require stakeholders and management agencies to create opportunities for knowledge transfer, the building of trust and understanding, recognition of property values and communities living within flood-prone areas, and funding mechanisms to set aside unstable sections of the river.

- **Scale** Consider processes across the entire watershed
- **Watershed setting** Determine the geology, hydrology and land-use (historical and present-day)
- **Dynamic equilibrium** Stable rivers are in "balance" between with their watershed inputs (water and sediment)
- **Streams are self-adjusting** Stream morphology =  $f(Q, Q_s, S, W/D, d_{50}, \text{bank material, vegetation, } \dots)$
- **Geomorphic thresholds** Catastrophic outcomes are the result when streams are out of equilibrium
- **Most flood damage is caused by water + sediment** Traditional approaches to flood management are not cost-effective over the long-term
- **Passive approach - manage the river corridor**
  - Requires redefining the relationship of public and private investments

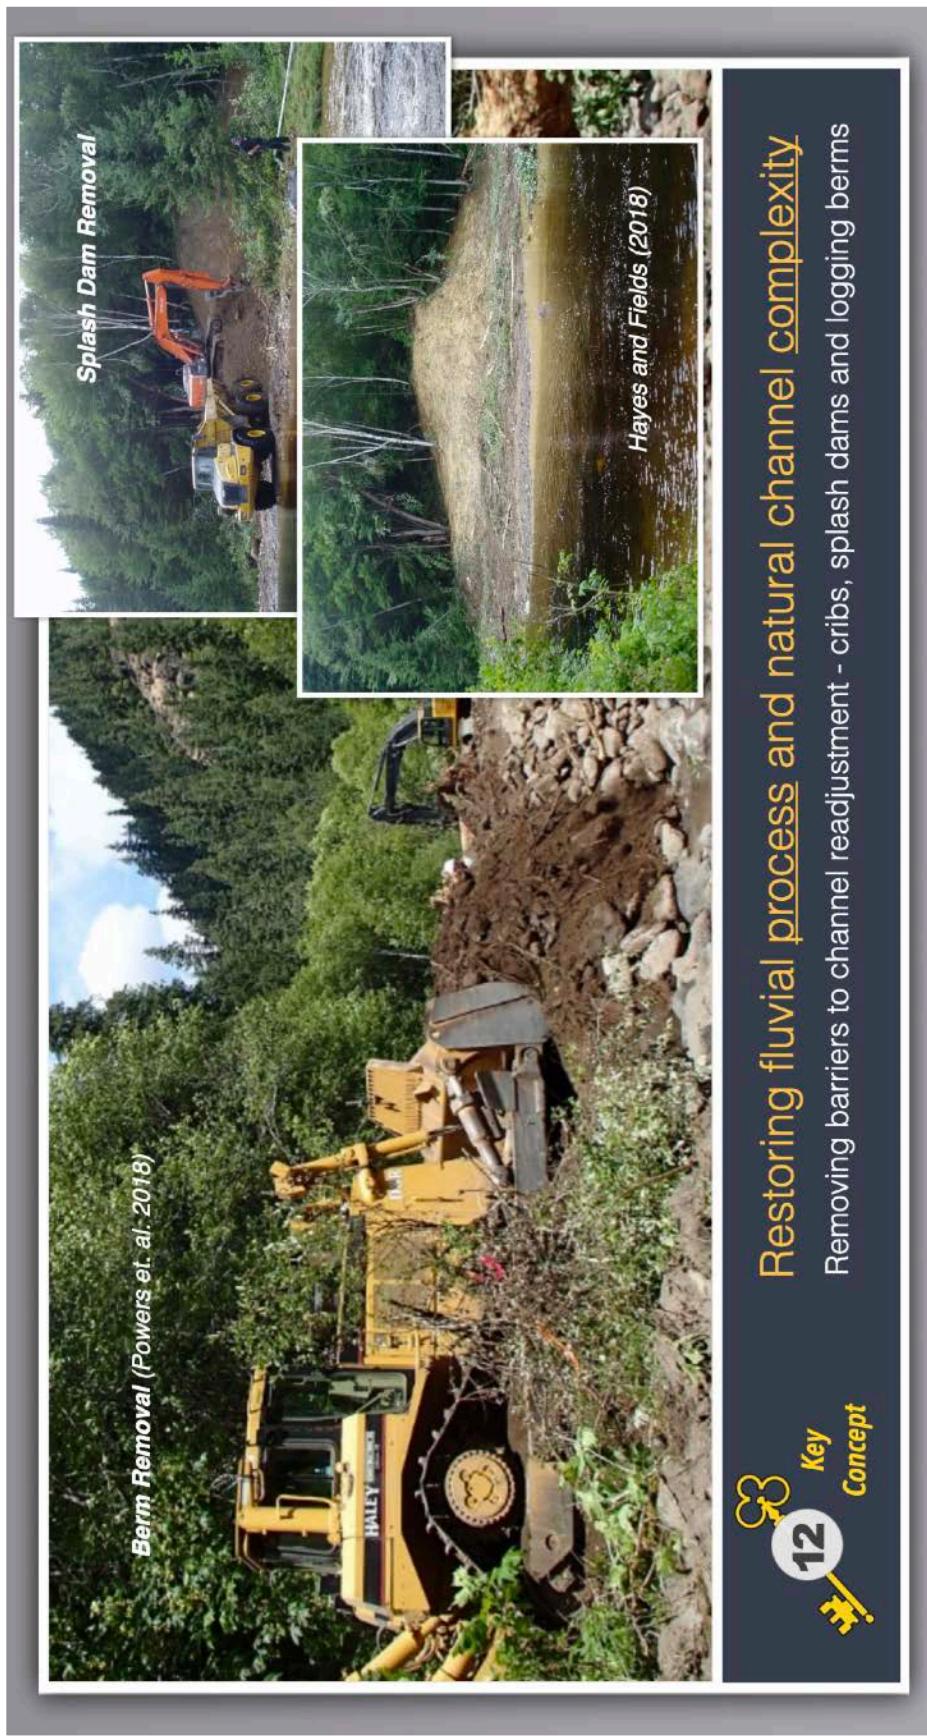
**Figure 37.** An example of removing berms and splash dams that prevent lateral and longitudinal connectivity of the stream to its floodplain and downstream-upstream reaches that are essential for restoring ecosystems, both aquatic and terrestrial.

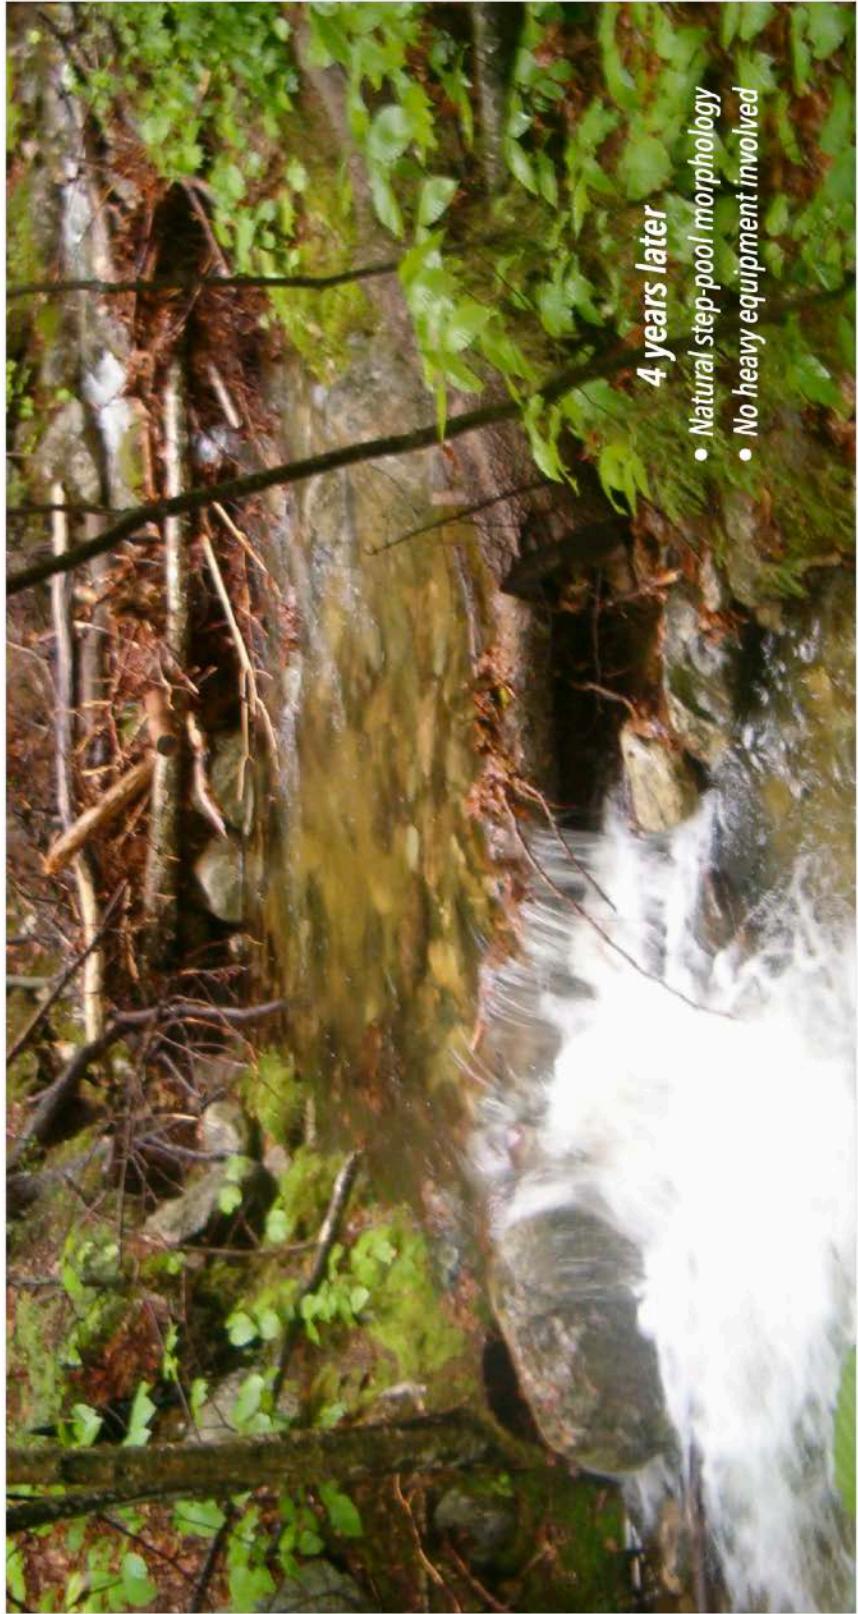
**Figure 40.** An example of naturally sorted LWD additions tend to create natural step-pool sequences in headwater streams for native brook trout. Notice the cut log in the foreground where the sawyer dropped the tree into the channel. Also note the retention of spawning gravels behind the log jams.

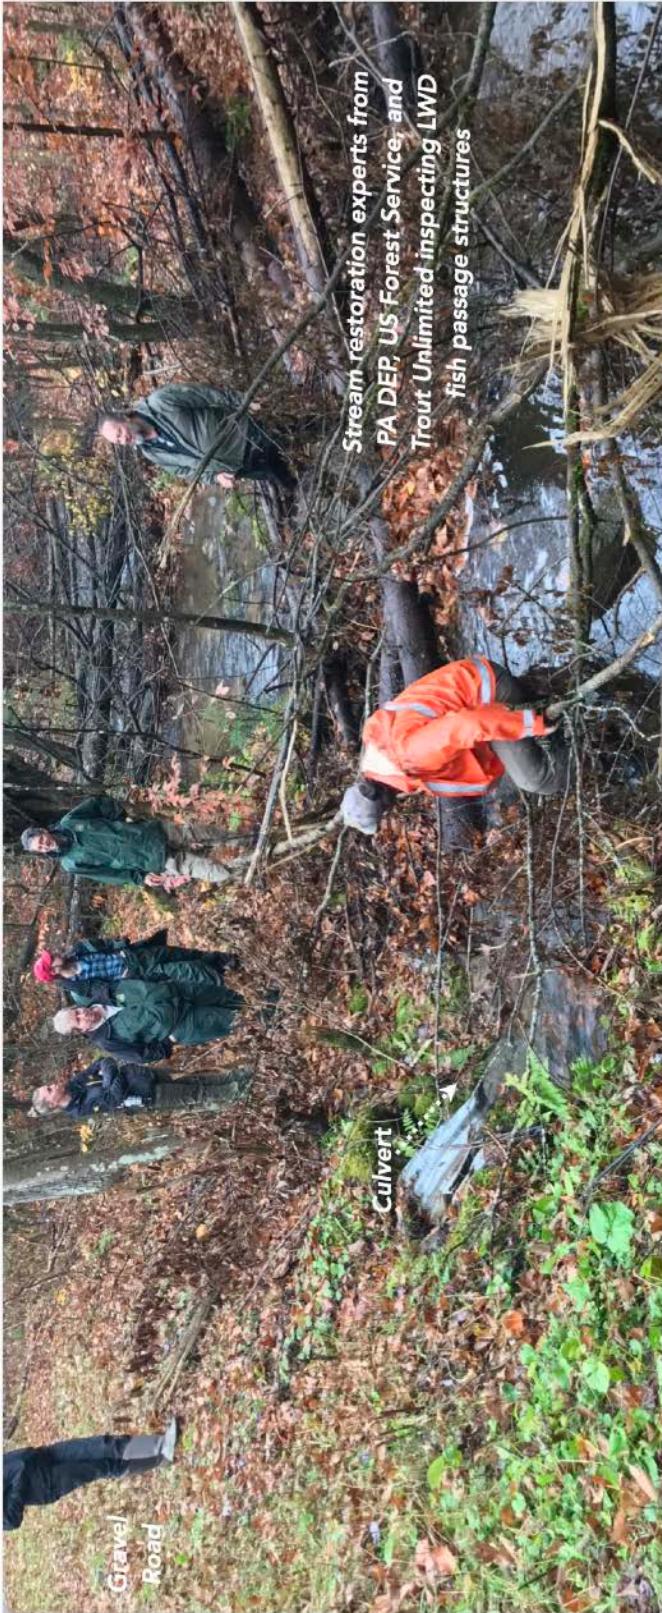
**Figure 41.** Smaller, carefully placed and tiered large woody debris additions to the channel at culvert and bridge crossings are proving very effective to promoting fish passage and reducing scour in the channel, as the wood debris dissipates energy from the culvert.

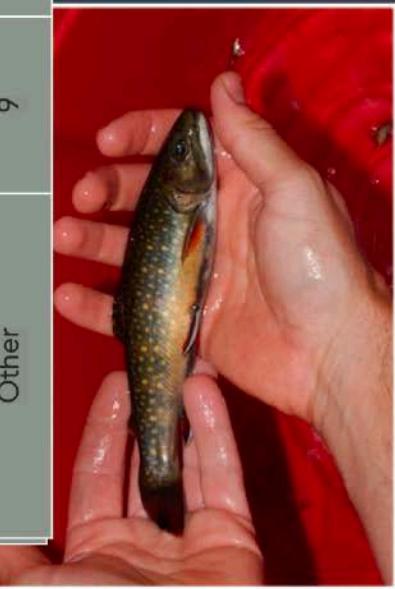
**Figure 44.** Another important aspect of this type of stream restoration is the retention of sediment, especially spawning gravels for fish so that populations of native species such as brook trout (shown in photo) can be self-sustaining over the long term and not require stocking.

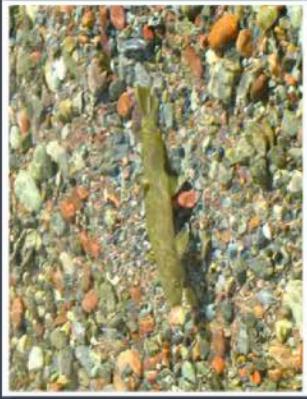
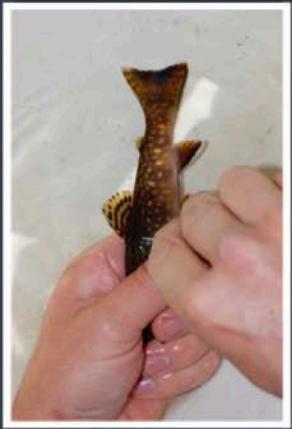
8-inch brook in redd

**Figure 45.** Within a short period of time the fish communities went from mostly dace to brook trout and age determinations show that their ages are self-sustaining.

Age	Before	After
YOY	7	19
1 yr	12	27
2 yr	5	12
>3 yr	0	4
Total	24	78
