Post-Flood Cleanup Alternatives Along Stream Corridors in Central Pennsylvania

A Scientific and River Engineering Perspective

Post-Flood Alternatives for River Corridor Management in Central Pennsylvania

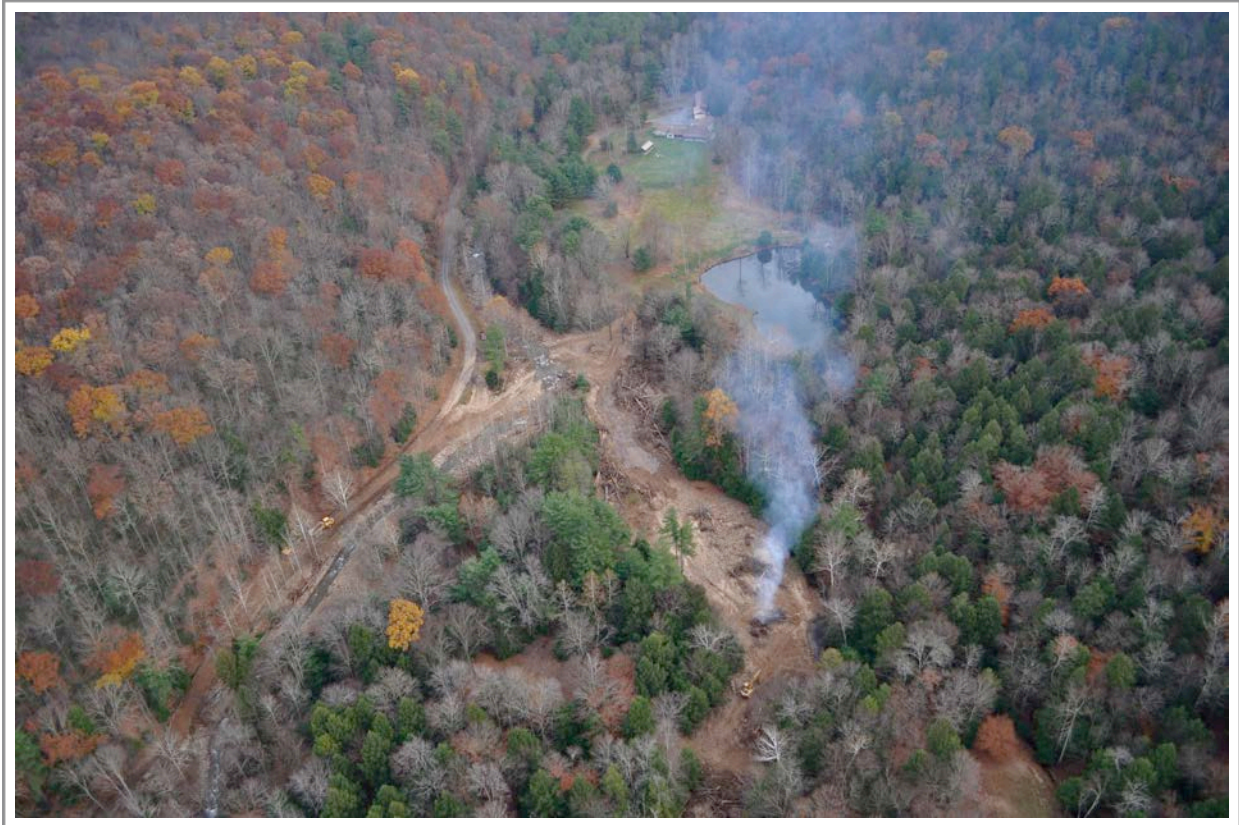
“Stream cleaning” efforts underway shortly after the devastating floods of Tropical Storm Lee in September 9-11, 2011. Big Bear Creek, a tributary to the Loyalsock Creek in the West Branch of the Susquehanna River in north-central Pennsylvania.

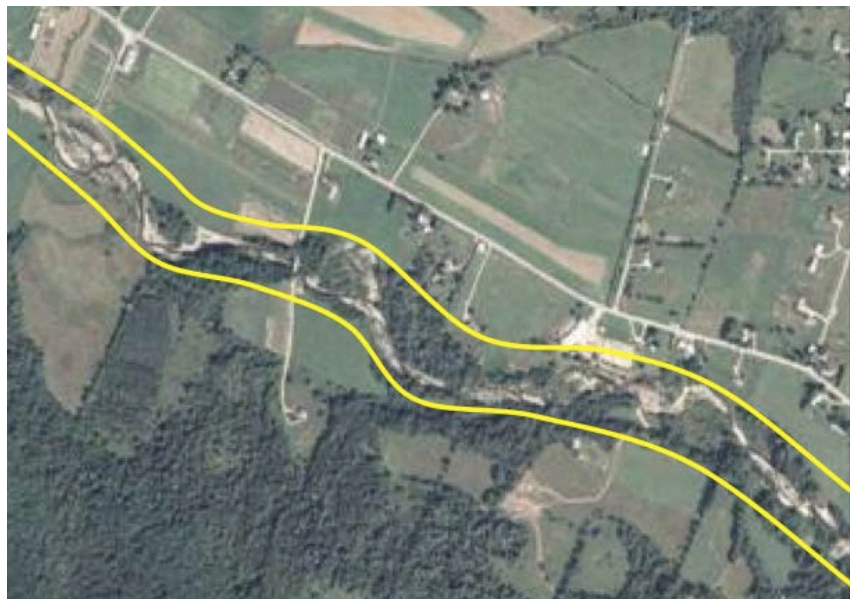
Defining and protecting the meander belt or stream width corridor that will accommodate equilibrium conditions may be the most important objective in any stream restoration and flood recovery project.

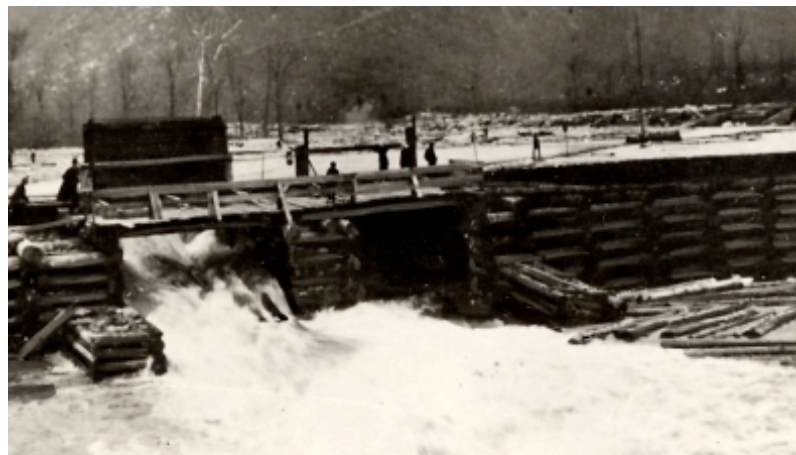
During the peak of the logging boom in the 1880s, watersheds such as this one - Pine Creek in the West Branch of the Susquehanna River - were completely denuded; their hillslopes were stripped bare of protective forests. Stream channels were straightened, snags removed, and temporary “splash dams” constructed to float the logs downstream to the saw mills and log booms of the Susquehanna. As a result, millions of tons of sediment were washed into the rivers, destabilizing the streams for decades. Geomorphic and hydrologic studies are showing that over the past 100 years, these logging legacy sediments are being flushed downstream with each major flood.

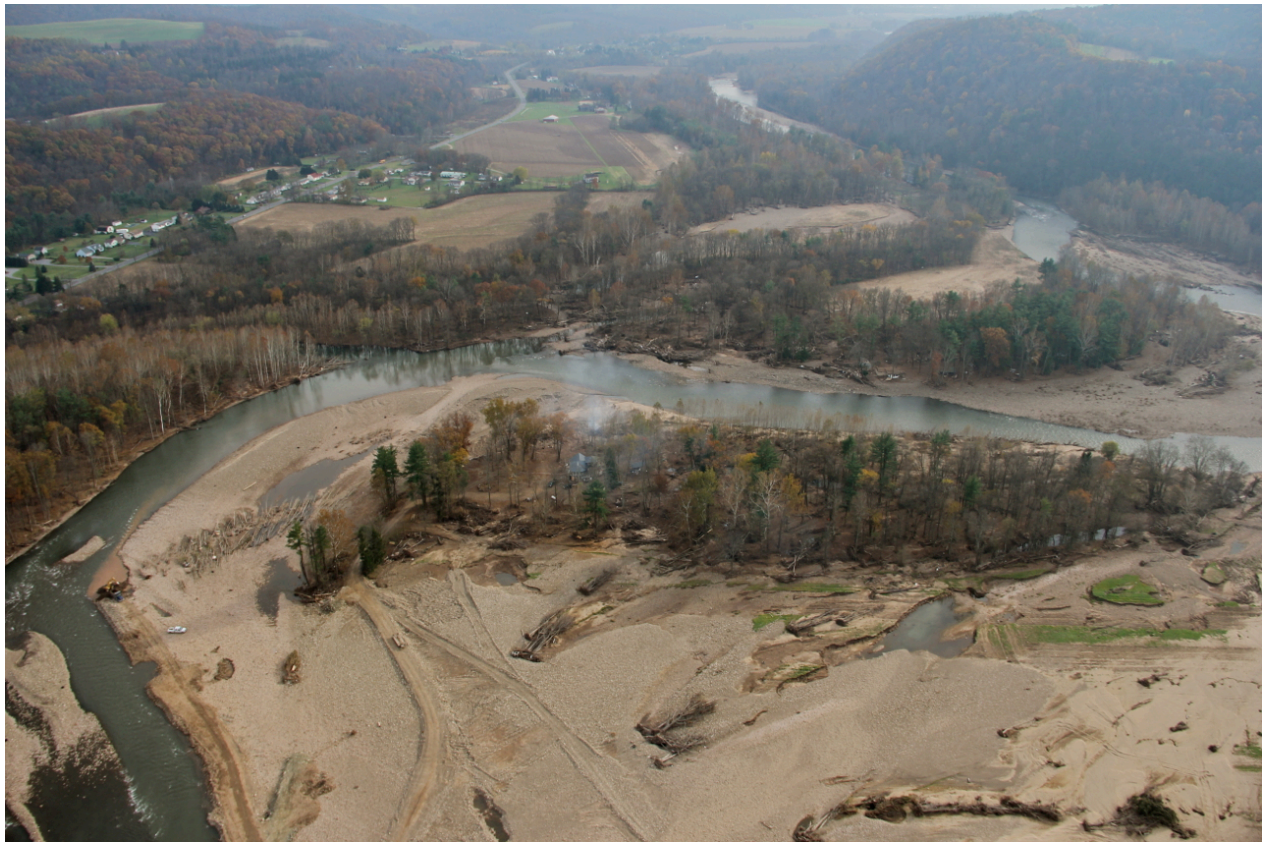
Aerial view of staggering amount sediment deposition in the channel and adjacent floodplain areas in the lower reaches of Loyalsock Creek during the record floods of Tropical Storm Lee on September 9-11, 2011. The river is adjusting its channel and floodplain corridor as it tries to accommodate enormous quantities of sand and gravel delivered to the headwater regions of the watershed during the logging era. The meandering low-flow channel is visible (note excavators and pickup trucks for scale), with gravel bars and braided high-flow channels visible across the forested floodplain corridor. Loyalsock Creek and most other streams in the north-central Pennsylvania remain in a protracted phase of adjustment from the complete deforestation of these watersheds 100 years ago. Enormous quantities of sediment were delivered to the river and pulses of gravel continue to work their way downstream during floods such as this one. Attempts to dredge, channelize, or realign streams in this condition are unsustainable and usually only increase flooding and channel erosion further downstream.

Try to minimize development in the entire river corridor is the most inexpensive and sustainable alternative in situations such as this. Efforts to rebuild homes or farm within the floodplain corridor stand a high likelihood of being damage by floods in the future as well - Loyalsock Creek needs this space to move the gravel through its system as seeks a new equilibrium state in the future.

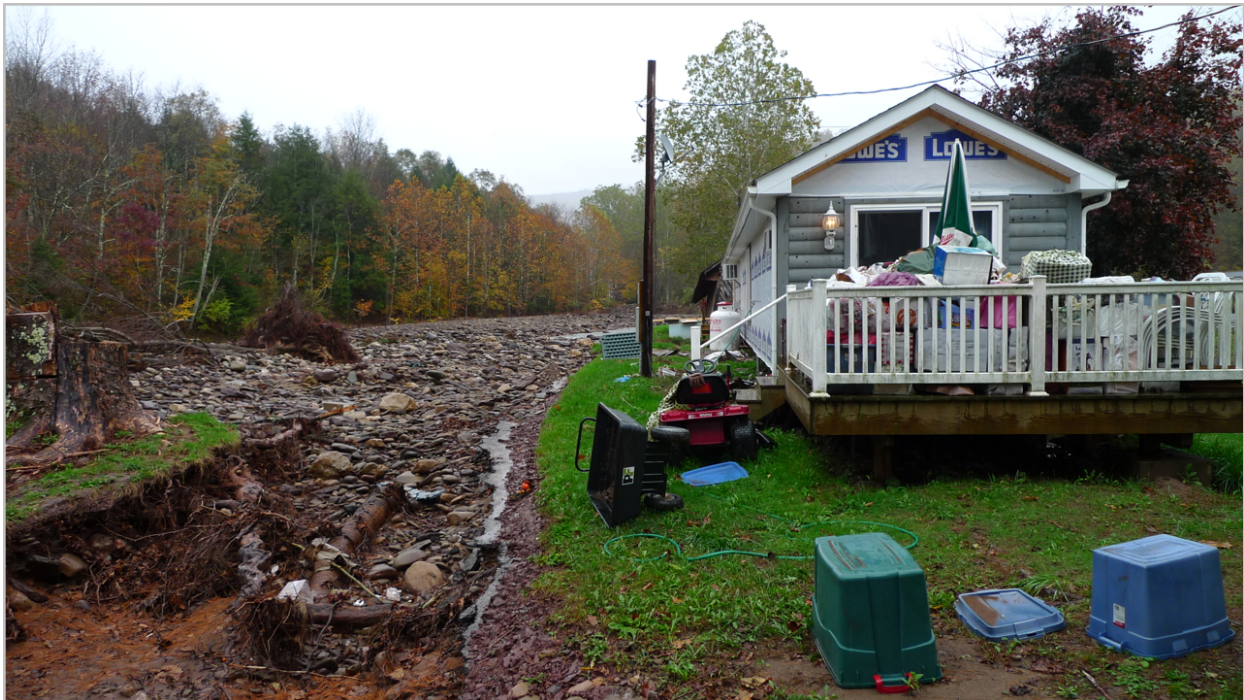
This property, located in the headwaters of the Muncy Creek watershed, has experienced increased erosion over the past forty years, since Hurricane Agnes in June 1972. Upstream, the channel was been straightened and bermed for log drives eighty years ago. Well-intended efforts and expenditures by the home owner to dredge the channel on the upstream end of the property have not been effective. In fact, the channel is returning to its braided, multithreaded condition it was in before European settlement and logging in the watershed took place. Efforts to constrain the channel to one static location will be unsustainable over the long term.

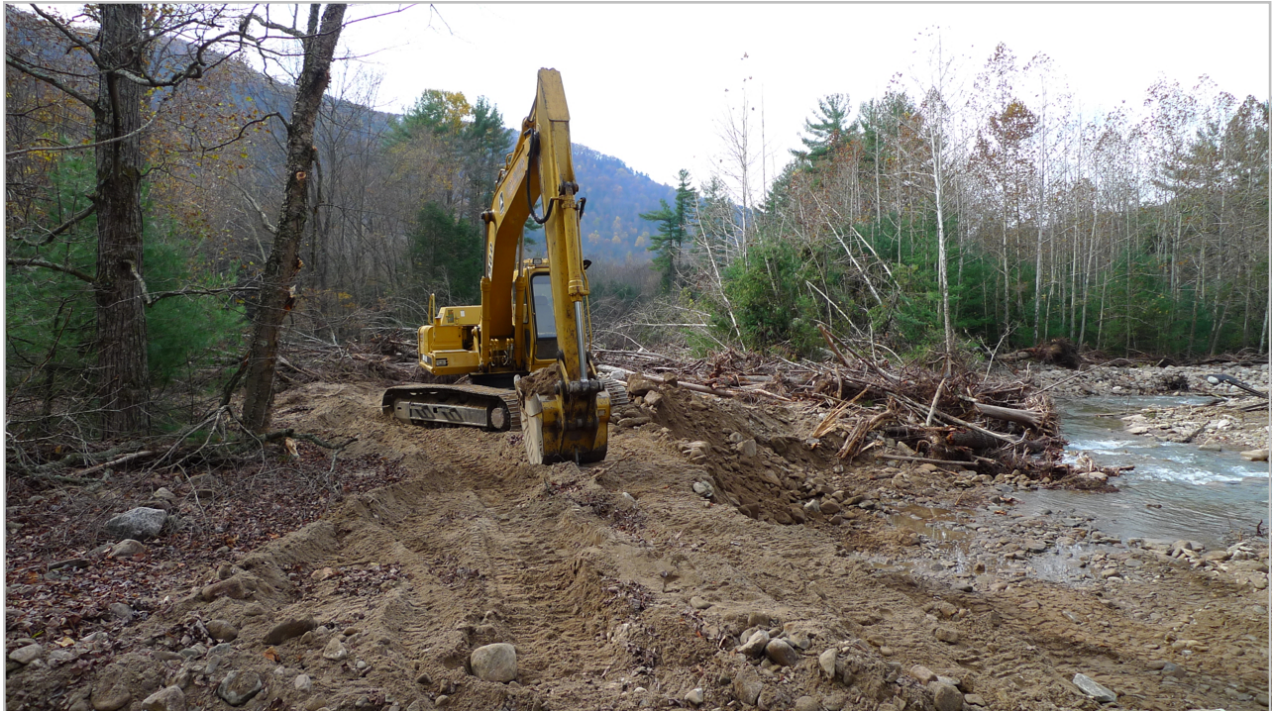
Stream ecosystems in Pennsylvania rely upon a complex cascade of water, nutrients, and woody debris for their health and survival. Flooding is a natural part of maintaining the stream, providing energy for the channel to rework its bed and bank and create new habitat for aquatic life. Trees washed into the channel provide fresh wood and organic material, complexity and refuge for trout, salamanders, and all life in the river.

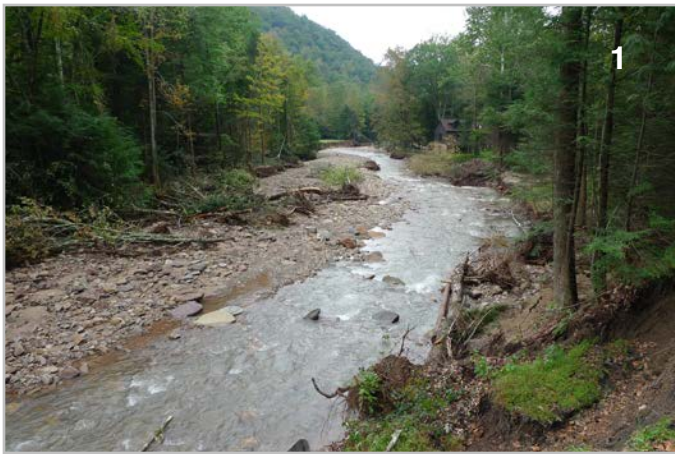
1. Immediately after the Tropical Storm Lee flood of record, September 9-11, 2011.

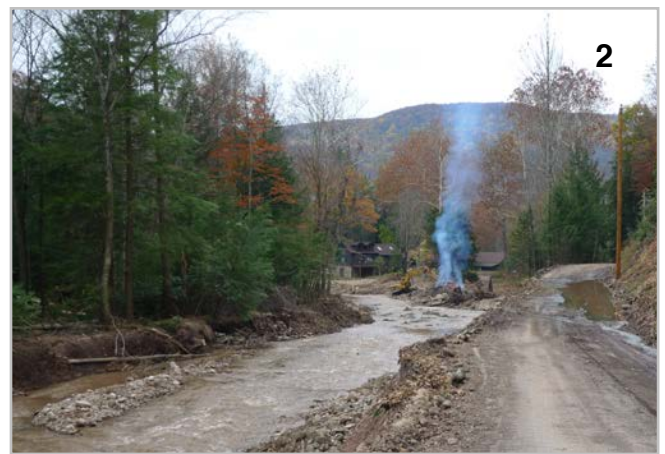
2. Snagging and burning of woody debris, gravel, realignment of channel, and installation of rock veins. (mid to late September, 2011)

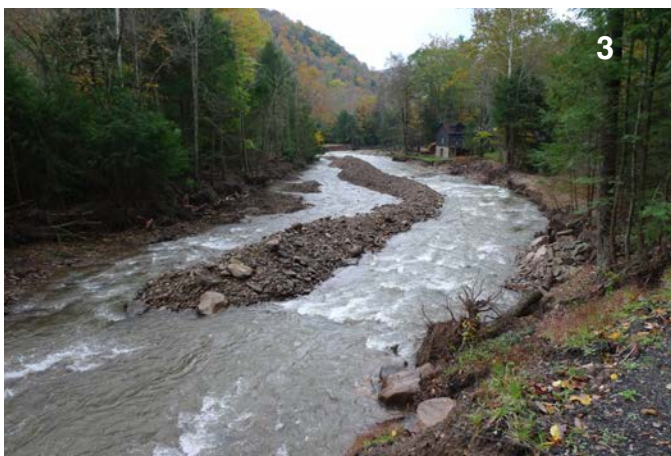
3. Removal of gravel point bar, realignment of main flow channel, regrading of channel slope and width. (late September 2011).

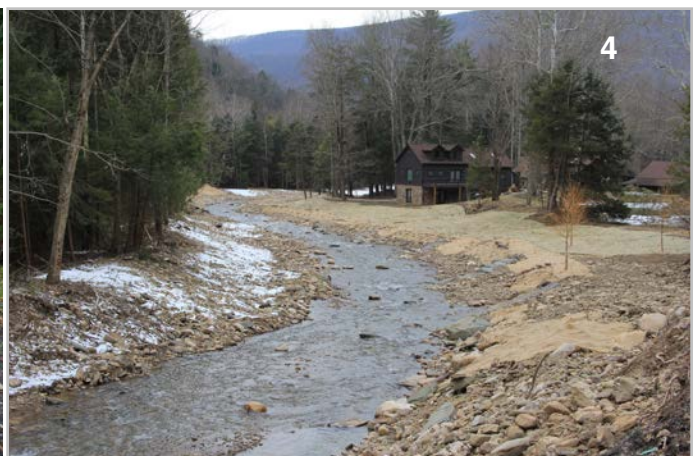
4. Reworking of channel banks, installation of rock veins on meander bend, regrading and armoring of channel banks. (October, 2011)
